### Modeling the Hydraulic and Water Quality habitat suitability for macrophytes in the mid-Snake River, Idaho

In cooperation with Idaho Department of Water Resources (IDWR)

**Project update Idaho Water Users Association January 18,2022**

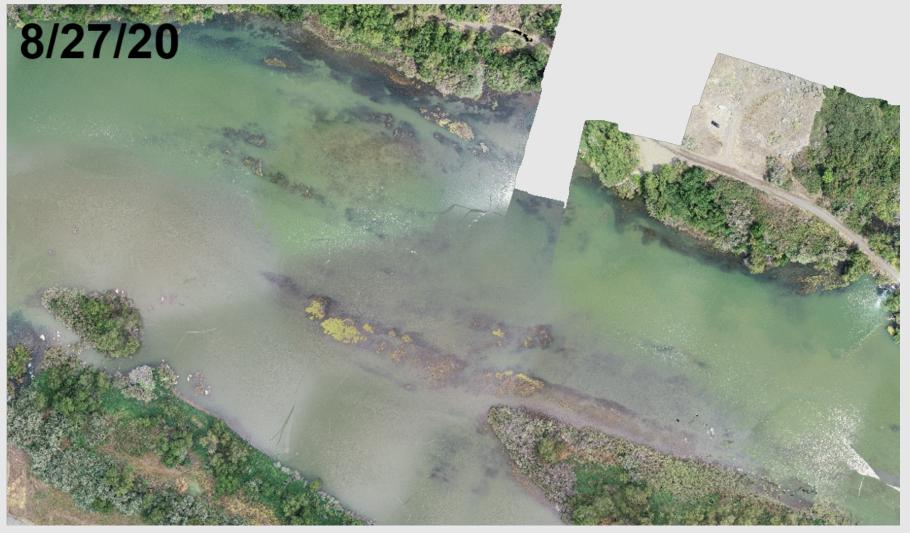
### **Drone Imagery – 2020 vs. 2021**
