Modeling the Hydraulic and Water Quality Habitat Suitability for Macrophytes in the mid-Snake River

Primary objectives

- 1) map extent of macrophyte beds within the Crystal Springs reach
- 2) develop a two-dimensional hydraulic model to simulate the stream summary for the depth and velocity, and
- 3) develop an integrated habitat suitability model of limiting conditions

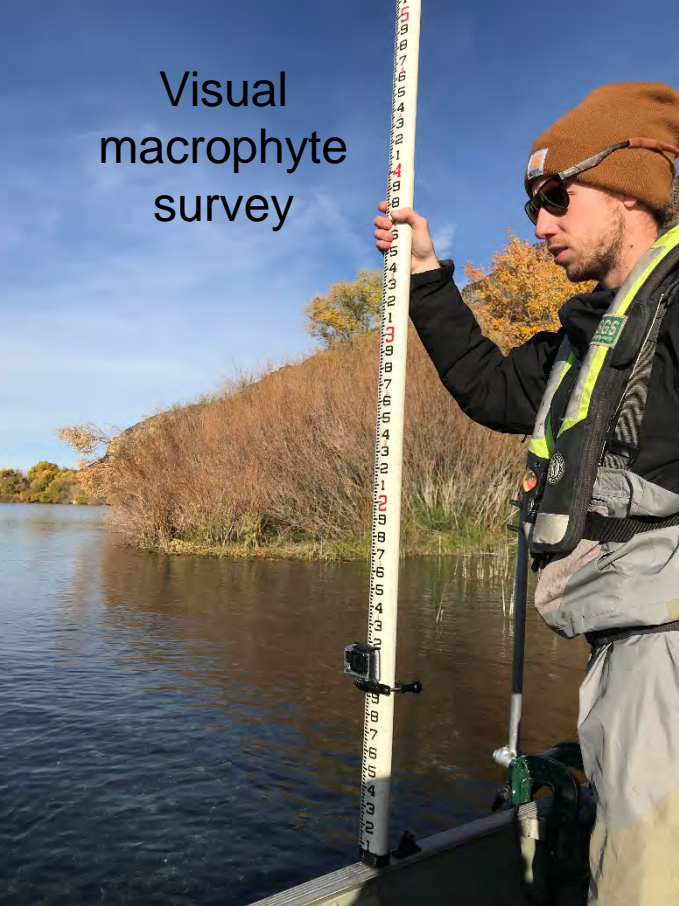
Example of macrophyte visual cover score of 1 (low)

- 5 – High (substrate covered, stems reaching surface)
- 3 – Moderate (substrate mostly covered, stems not reaching surface)
- 1 – Low (plants visible, substrate mostly uncovered)
- 0 – Absent or very sparse

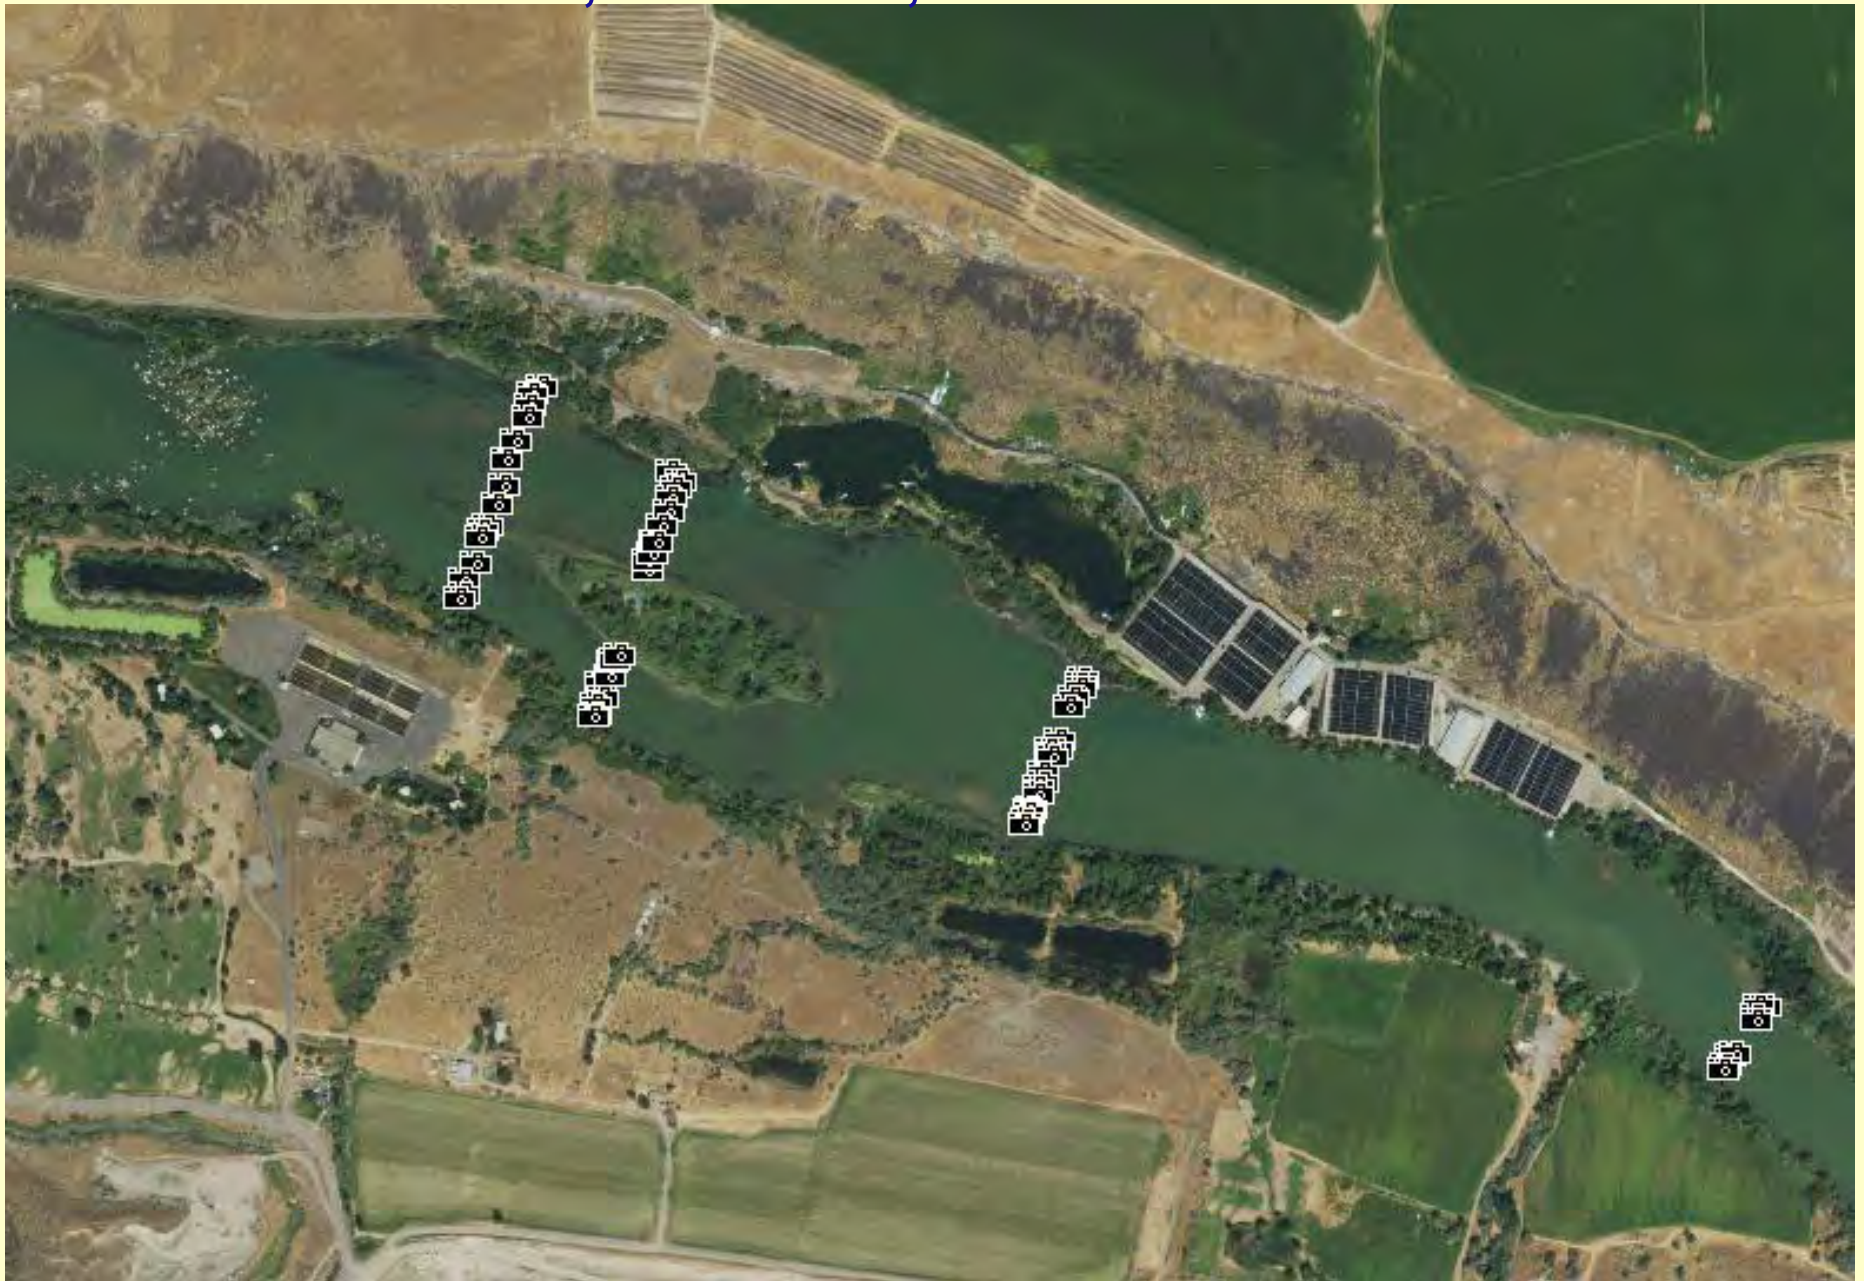
Falter's Island, Crystal Springs Reach of the Snake River, October 26, 2019

Total P 96 $\mu\text{g/L}$, Total dissolved P- 30 $\mu\text{g/L}$, OP 36 $\mu\text{g/L}$

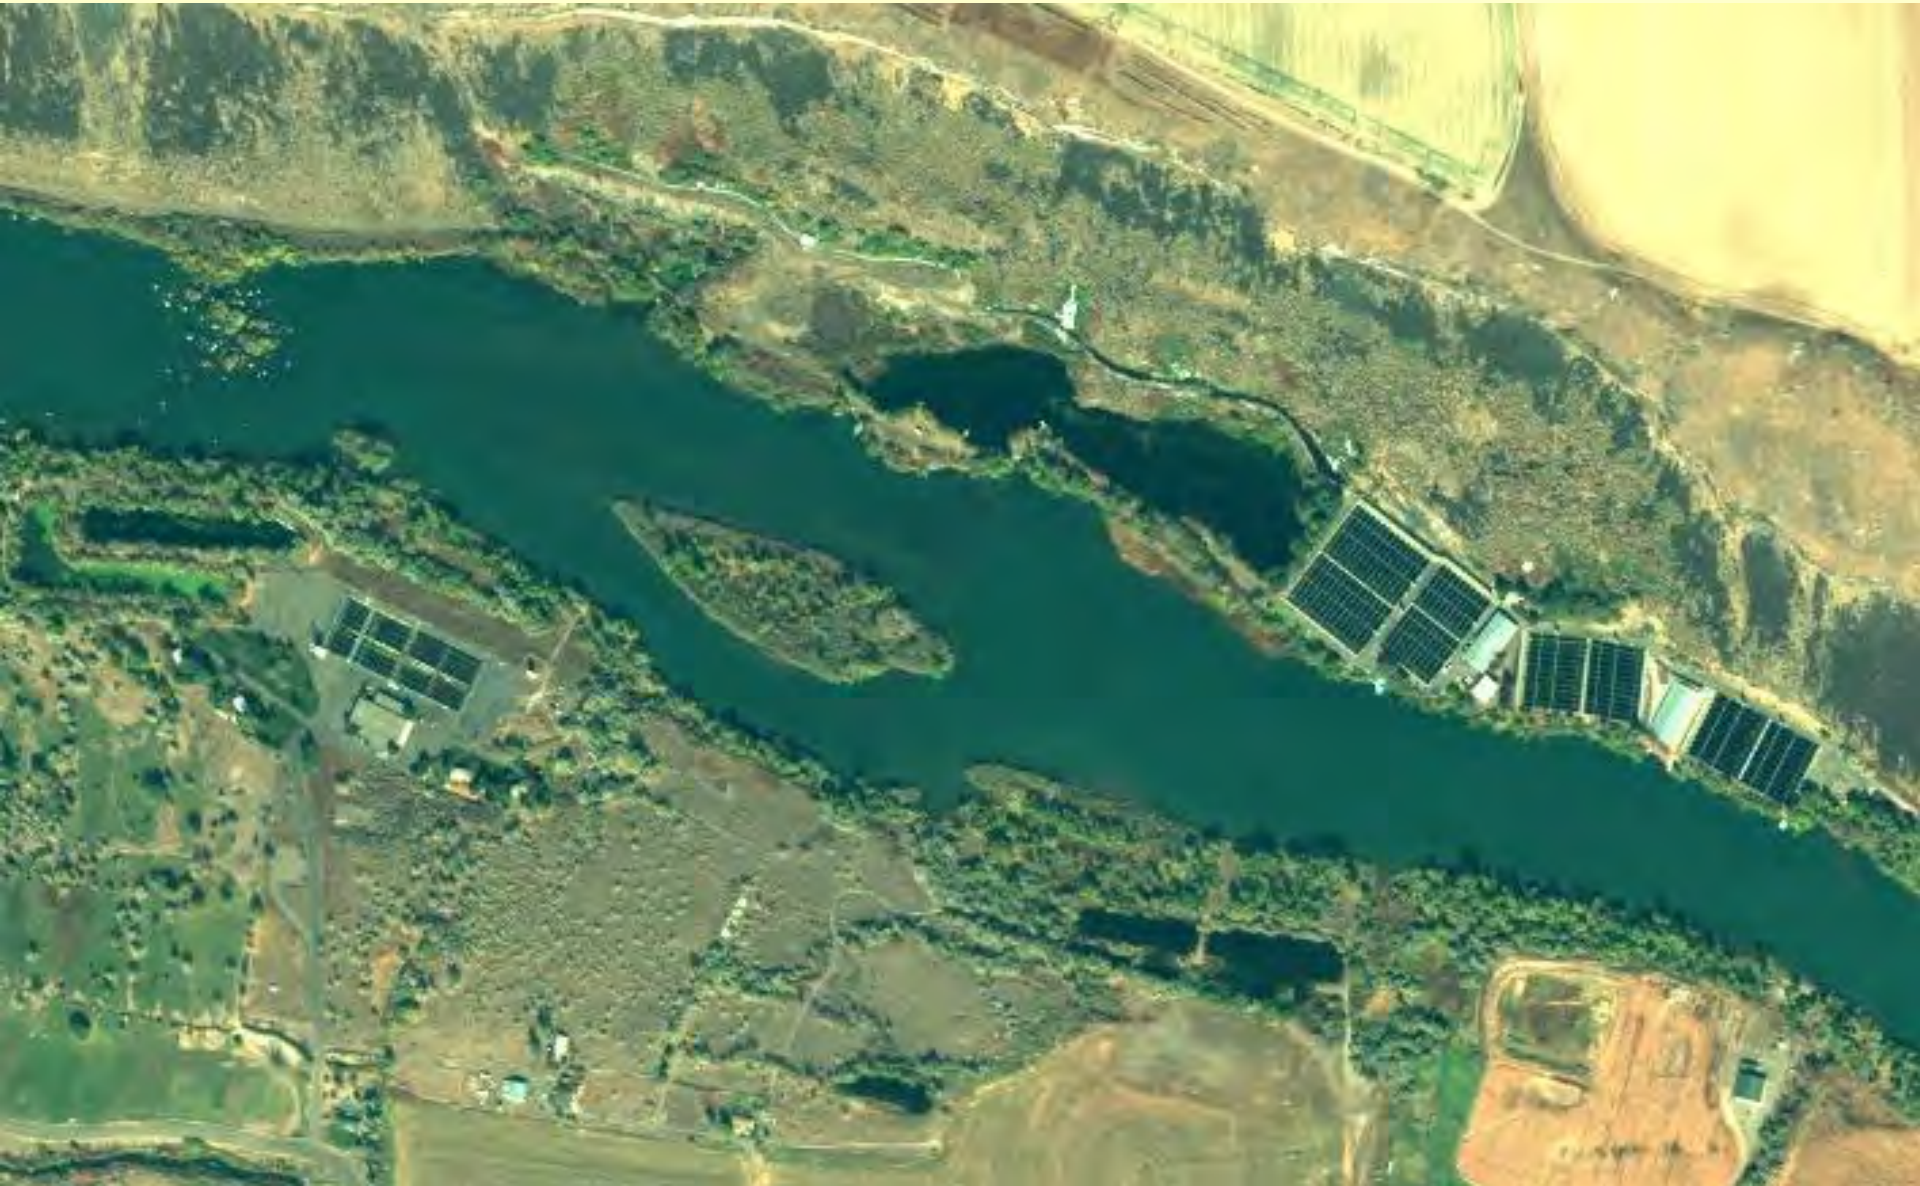
Falter's Island, Crystal Springs Reach of the Snake River, August 29, 1993

Total P, 105 $\mu\text{g/L}$; Total dissolved P, 60 $\mu\text{g/L}$, OP 55 $\mu\text{g/L}$

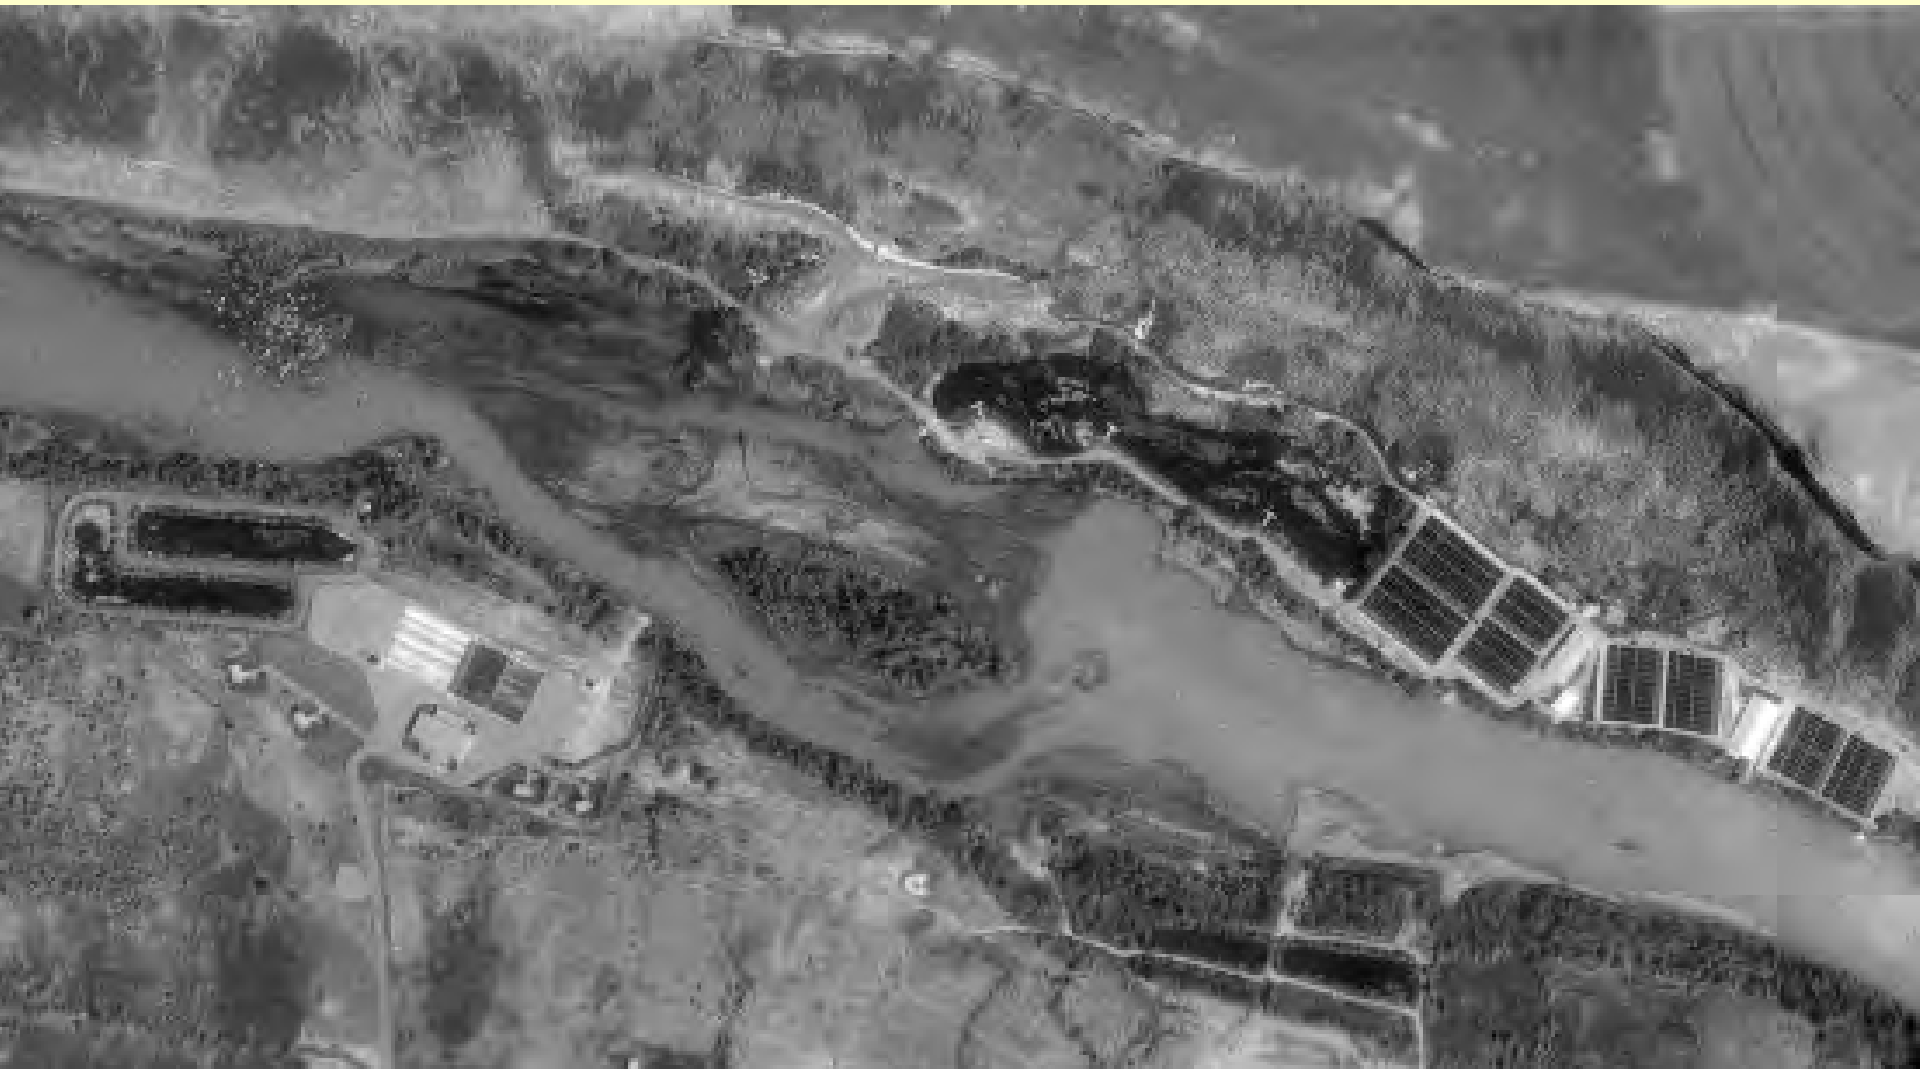
Falter's Island, Crystal Springs Reach of the Snake River, 9/9/2004

Total P 111 $\mu\text{g/L}$, OP 73 $\mu\text{g/L}$

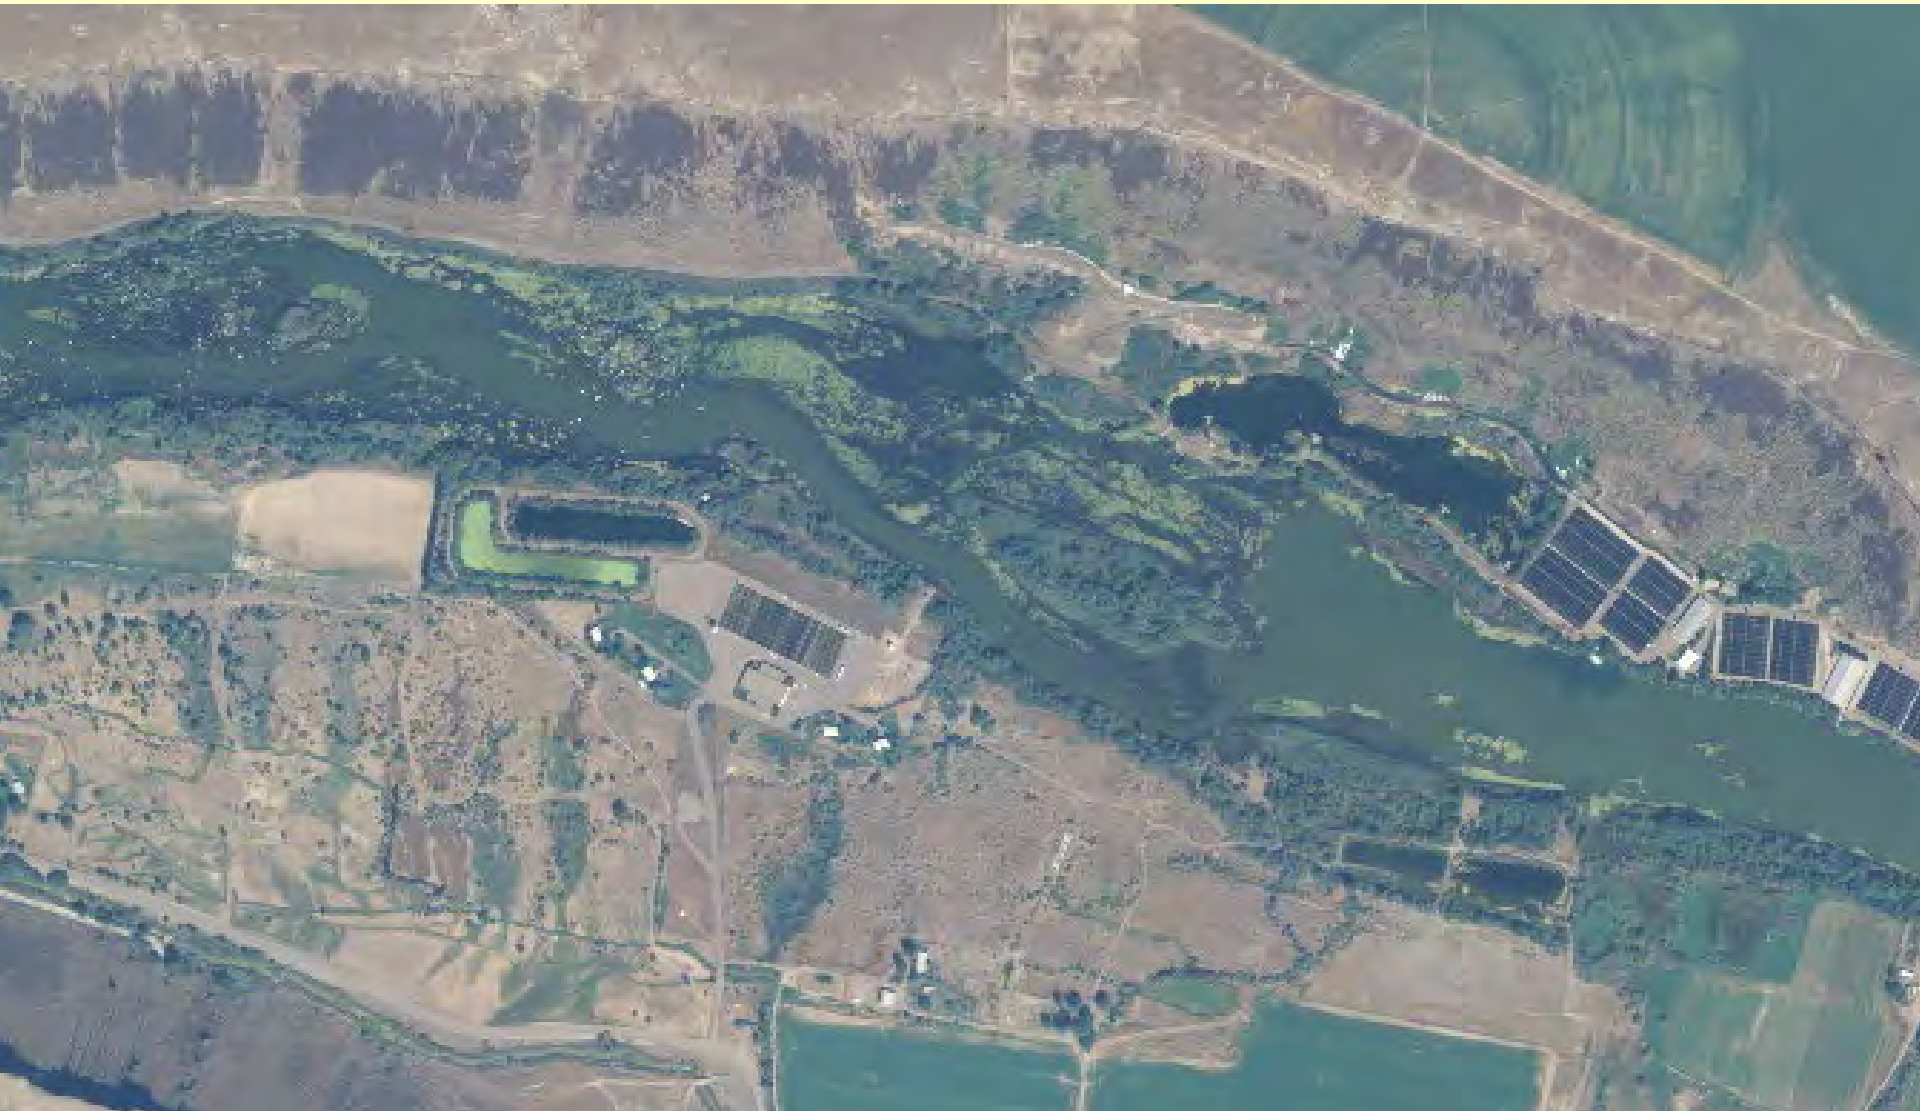
High growth periods were associated with low peak flows

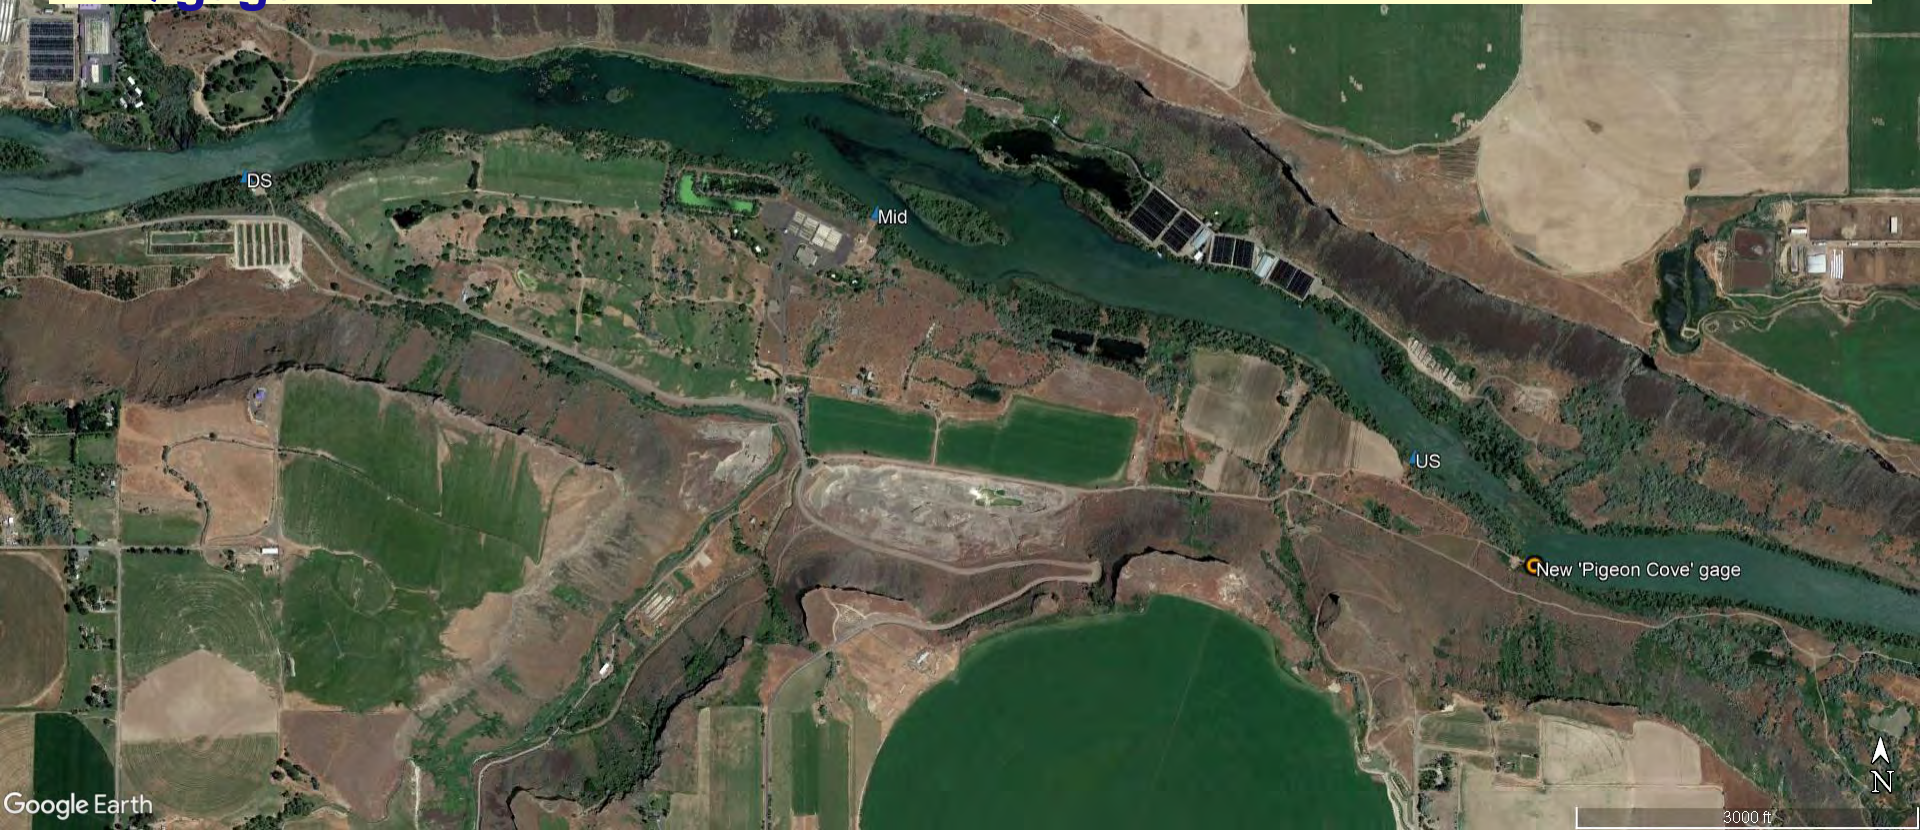
Crystal Springs reach gages

1 New real-time discharge gage, 3 temporary stage gages, 1 real-time WQ gage

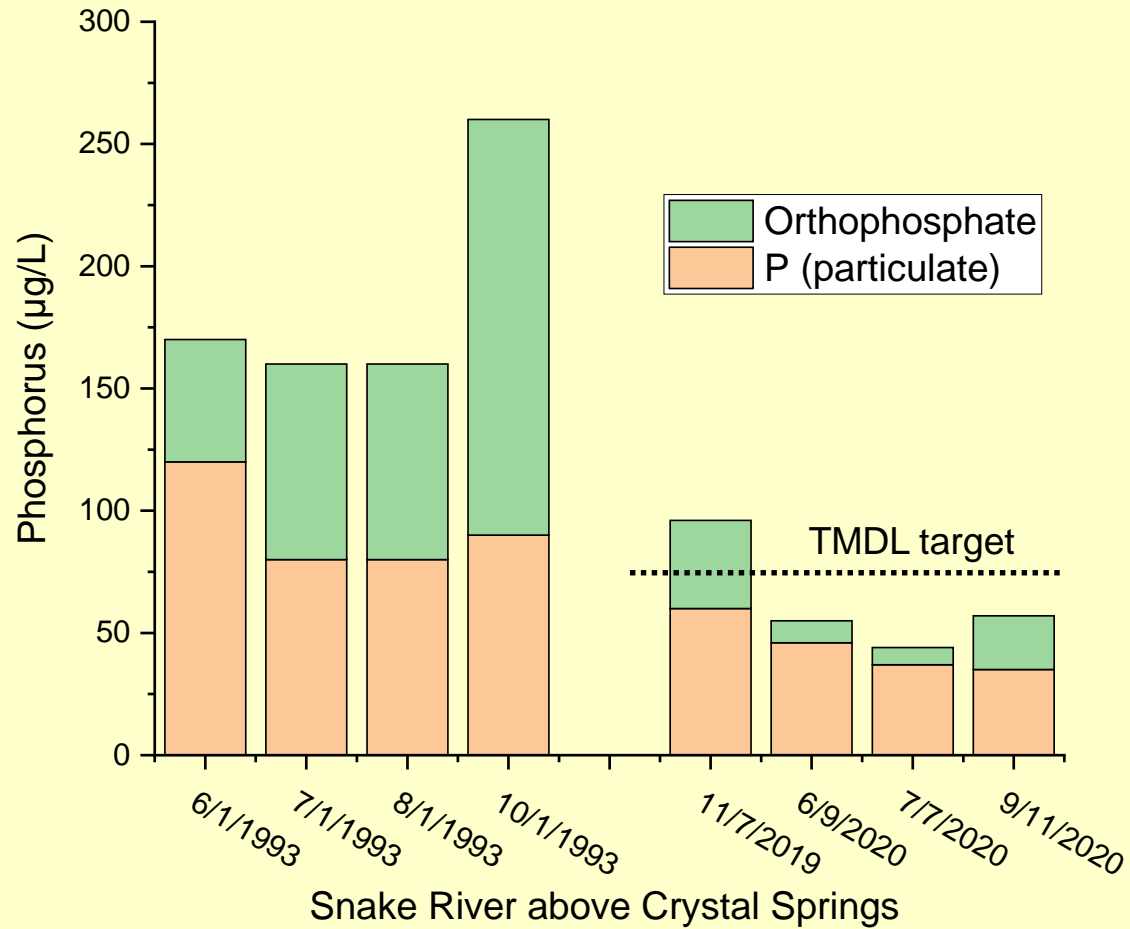
Phosphorus concentrations in the 'Falter Reach' then and now

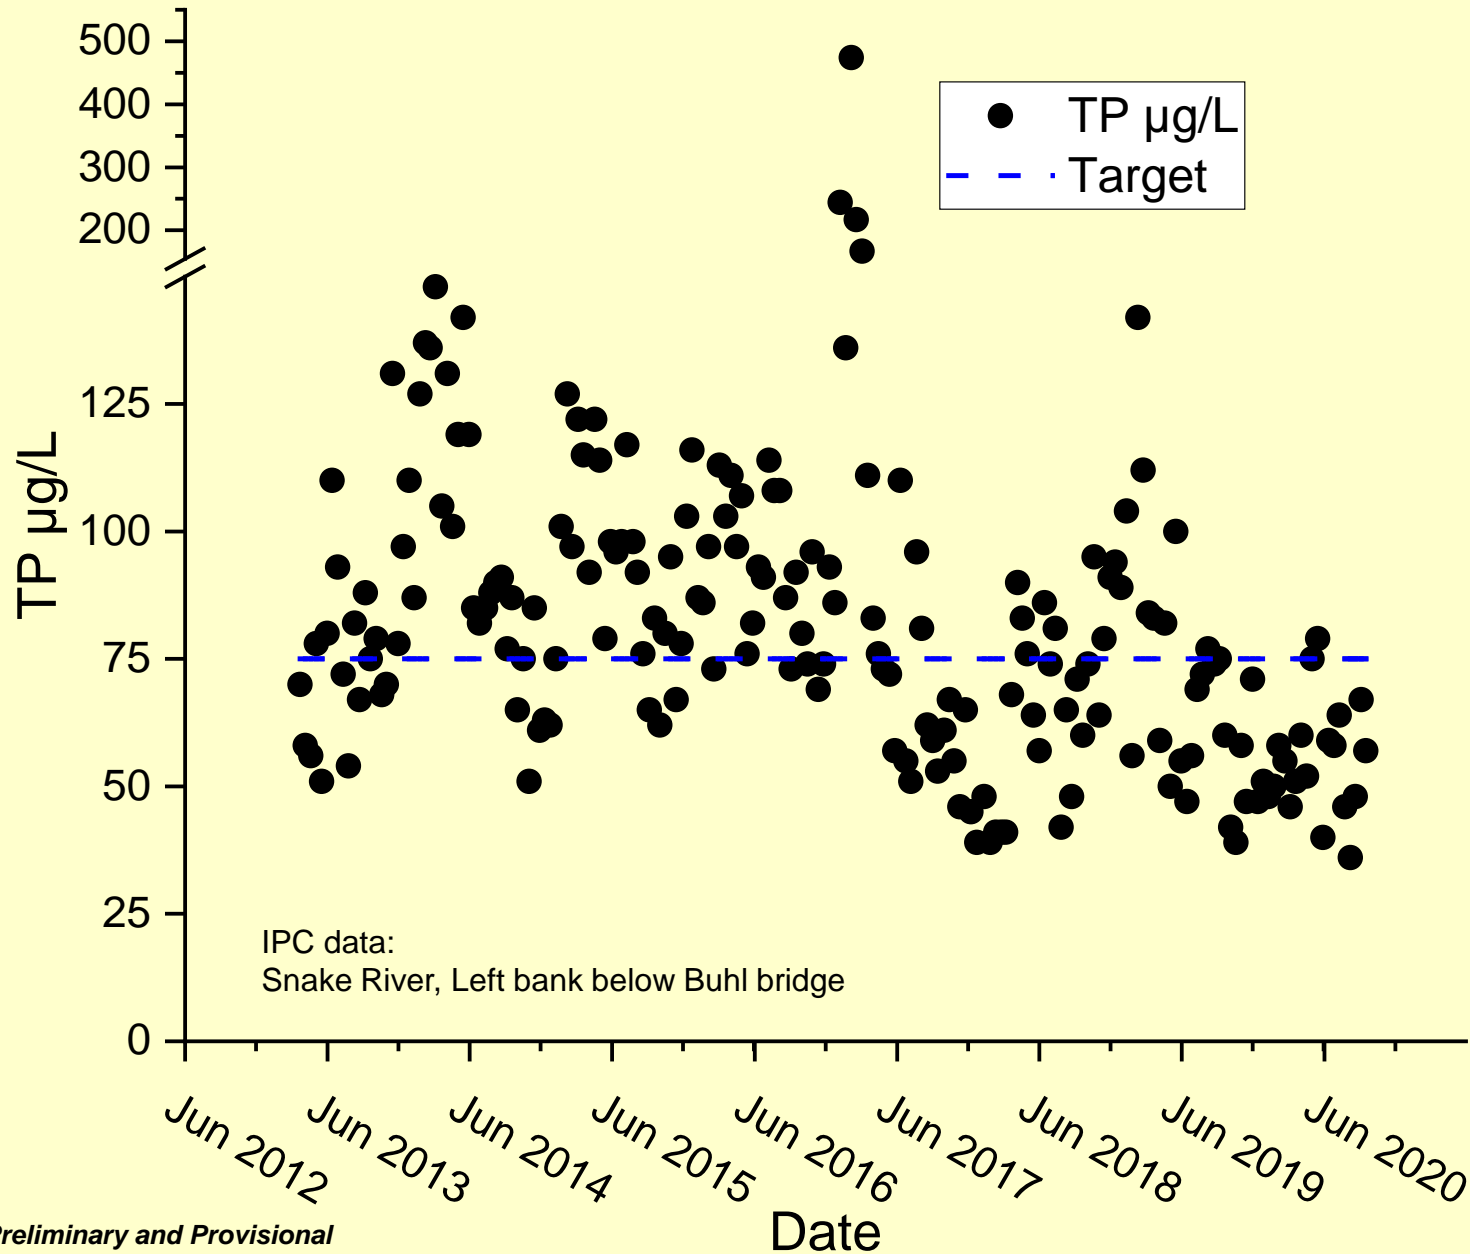
Phosphorus concentrations, Snake River at Buhl: was 2020 a one off?

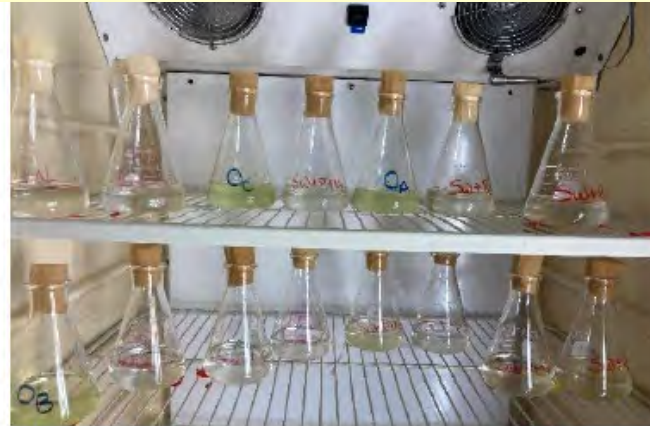
Photo 2: All samples in the incubator on Day 4.

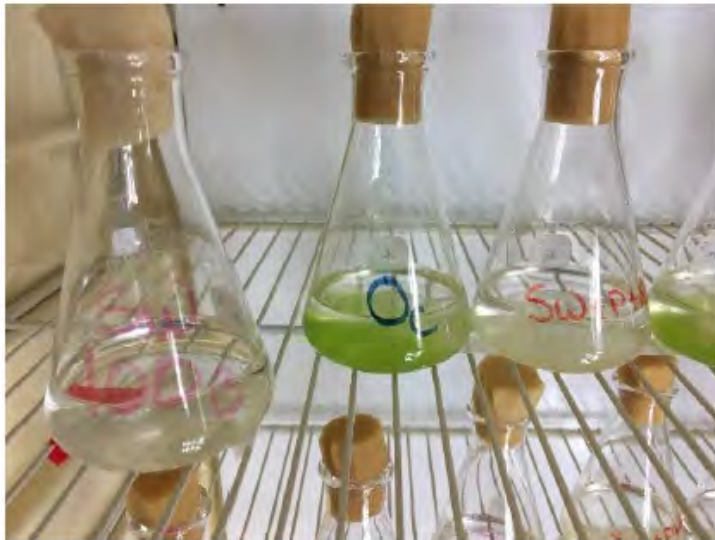
Photo 3: From left to right, site water without nutrients, lab water control, and site water + N and + P on Day 5

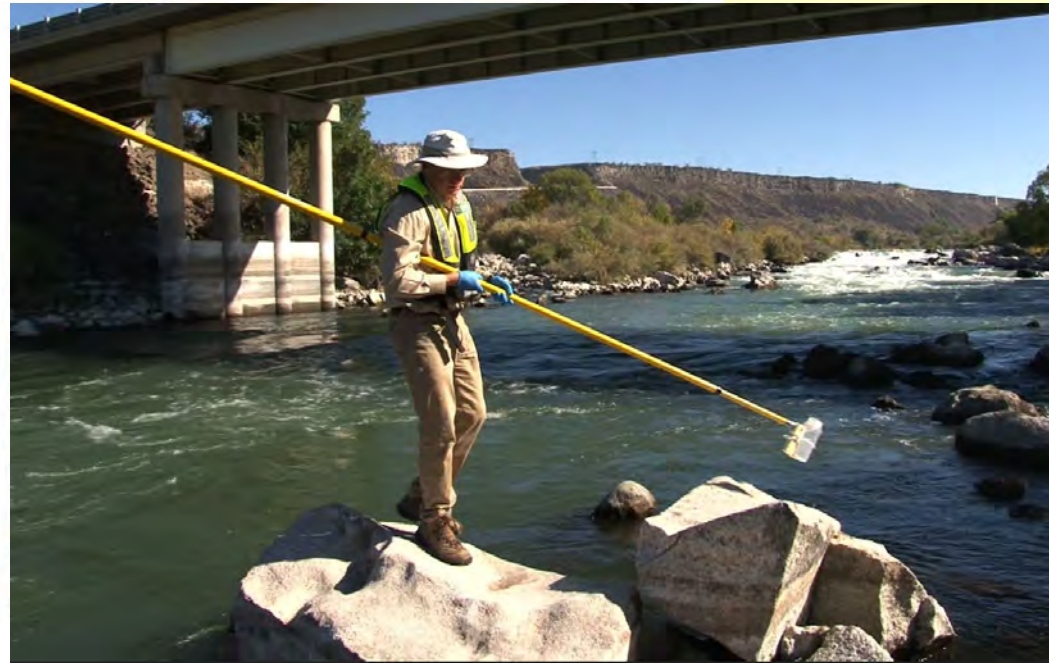
Which nutrient(s) are limiting algal growth in the Snake River?
